CONNECTICUT RIVER BASIN
HOLYOKE, MASSACHUSETTS

McLEAN RESERVOIR

MA 00539

PHASE I INSPECTION REPORT
NATIONAL DAM INSPECTION PROGRAM

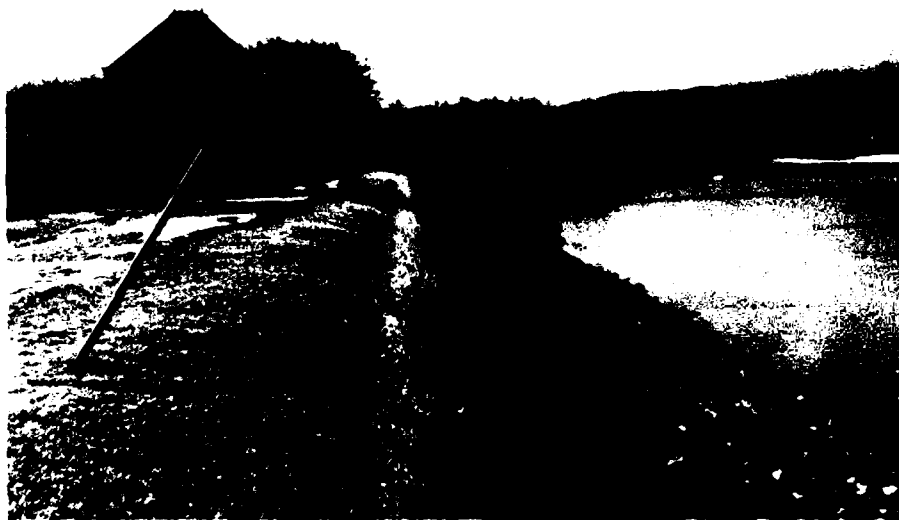
The riprap is in good condition and no slumping or slides were observed above the reservoir level.

PHOTO NO. 1 - Crest and upstream face of dam.

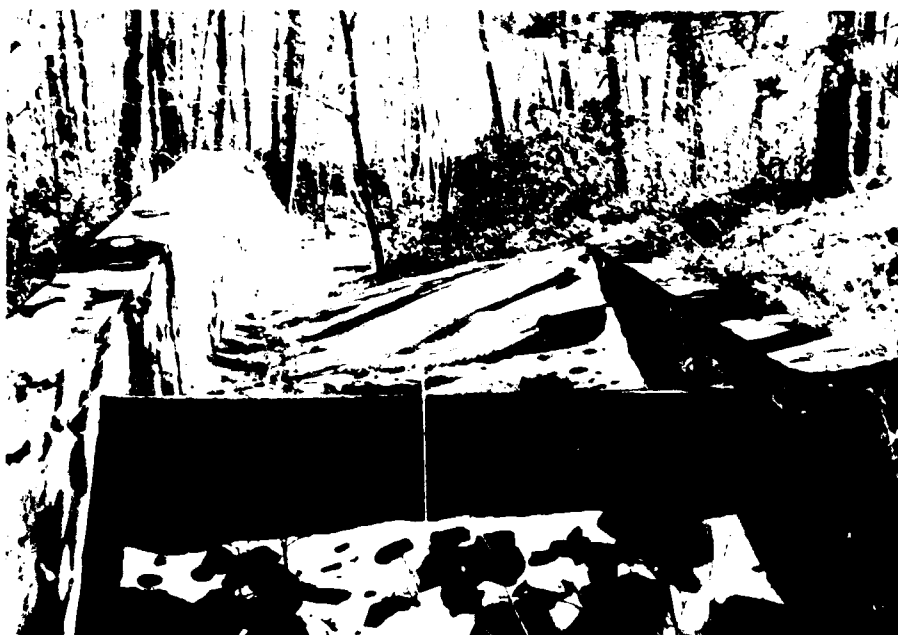
The spillway was observed to be in poor condition with excessive spalling and deterioration.

PHOTO NO. 3 - Spillway weir and outlet channel.

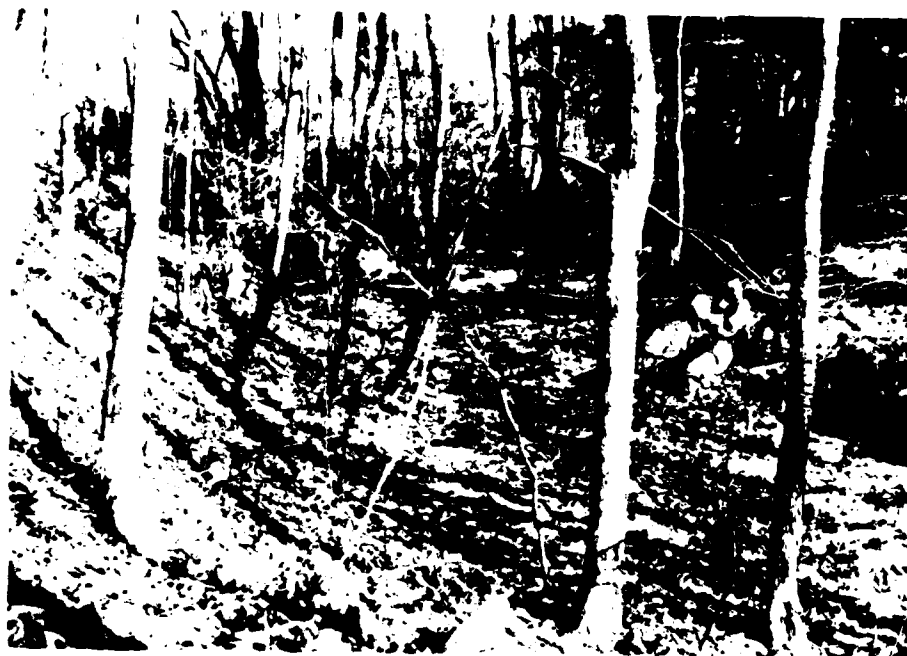
There are numerous bedrock outcrops at the toe of the downstream slope as shown in photos 7 and 9. The observation is consistent with early drawings of the dam which indicate it is founded on bedrock.

PHOTO NO. 7 - Toe of embankment viewed from bottom of spillway channel toward left abutment.
